**DEPARTMENT OF TRANSPORTATION**

Contract #: 04-0120F4Cty: SF/ALA Rte: 80 PM: 13.2/13.9File #: 99.28**WELDING INSPECTION REPORT****Resident Engineer:** Casey, William**Address:** 333 Burma Road**City:** Oakland, CA 94607**Report No:** WIR-027668**Date Inspected:** 11-May-2012**Project Name:** SAS Superstructure**OSM Arrival Time:** 700**Prime Contractor:** American Bridge/Fluor Enterprises, a JV**OSM Departure Time:** 1530**Contractor:** American Bridge**Location:** Coraopolis PA**CWI Name:** Dennis Hildebrand**CWI Present:** Yes No**Inspected CWI report:** Yes No N/A**Rod Oven in Use:** Yes No N/A**Electrode to specification:** Yes No N/A**Weld Procedures Followed:** Yes No N/A**Qualified Welders:** Yes No N/A**Verified Joint Fit-up:** Yes No N/A**Approved Drawings:** Yes No N/A**Approved WPS:** Yes No N/A**Delayed / Cancelled:** Yes No N/A**Bridge No:** 34-0006**Component:** Anchor Plate Spherical Bearings**Summary of Items Observed:**

# WELDING INSPECTION REPORT

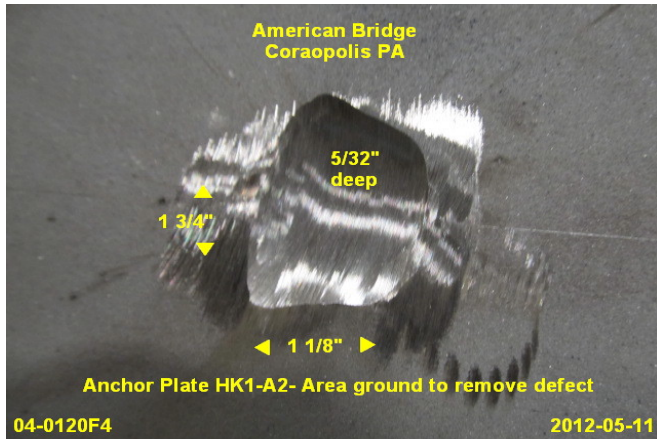
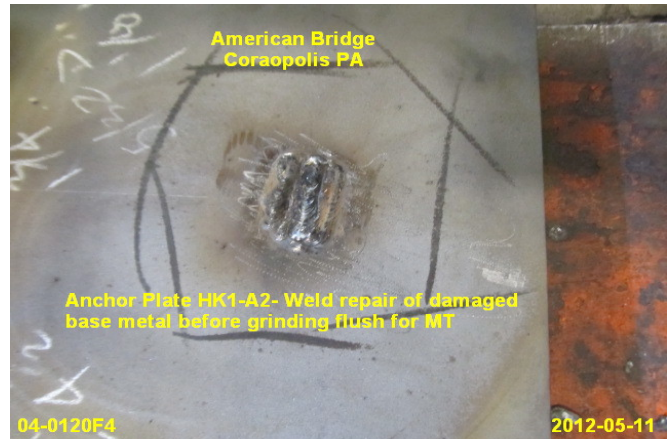
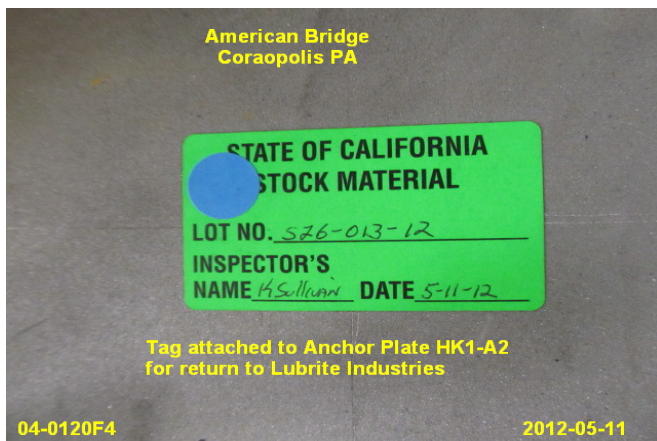
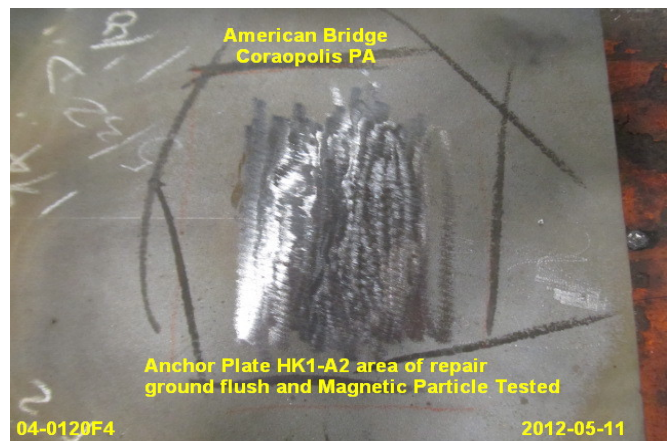
This Quality Assurance Inspector (QAI) arrived at American Bridge (AB), Coraopolis PA, as requested per TL 38 to monitor Repairs to Anchor Plate HK1-A2 which was damaged during welding of anchor studs at Lubrite Industries, Meadville PA, on 5/7/12.

Plate was set up on welding table and crater was ground until all signs of defect were removed. An area approximately 1 3/4" x 1 1/8" x 5/32" deep was ground. The area was then Magnetic Particle tested using the yoke method. The Technician performing the test is certified per ASNT level II requirements. No indications showed up from the MT. The excavation was then released for welding per approved weld and repair Procedure. The welding was performed by a qualified welder and witnessed by QC and this QAI. The surface of the weld repair area was then ground flush with the surface of the base metal. The repair area was then Magnetic Particle Tested for verification of sound repair metal. No indications were revealed during the test.
